**Subject: Storm Water Evaluation
Terminal 5 Upland Facility
ECSI No. 1686**

- Figure 1 – Site Location Map
- Figure 2 – Site Facility and Storm Water Map

Storm Water Evaluation
Terminal 5 Upland Facility
Portland, Oregon

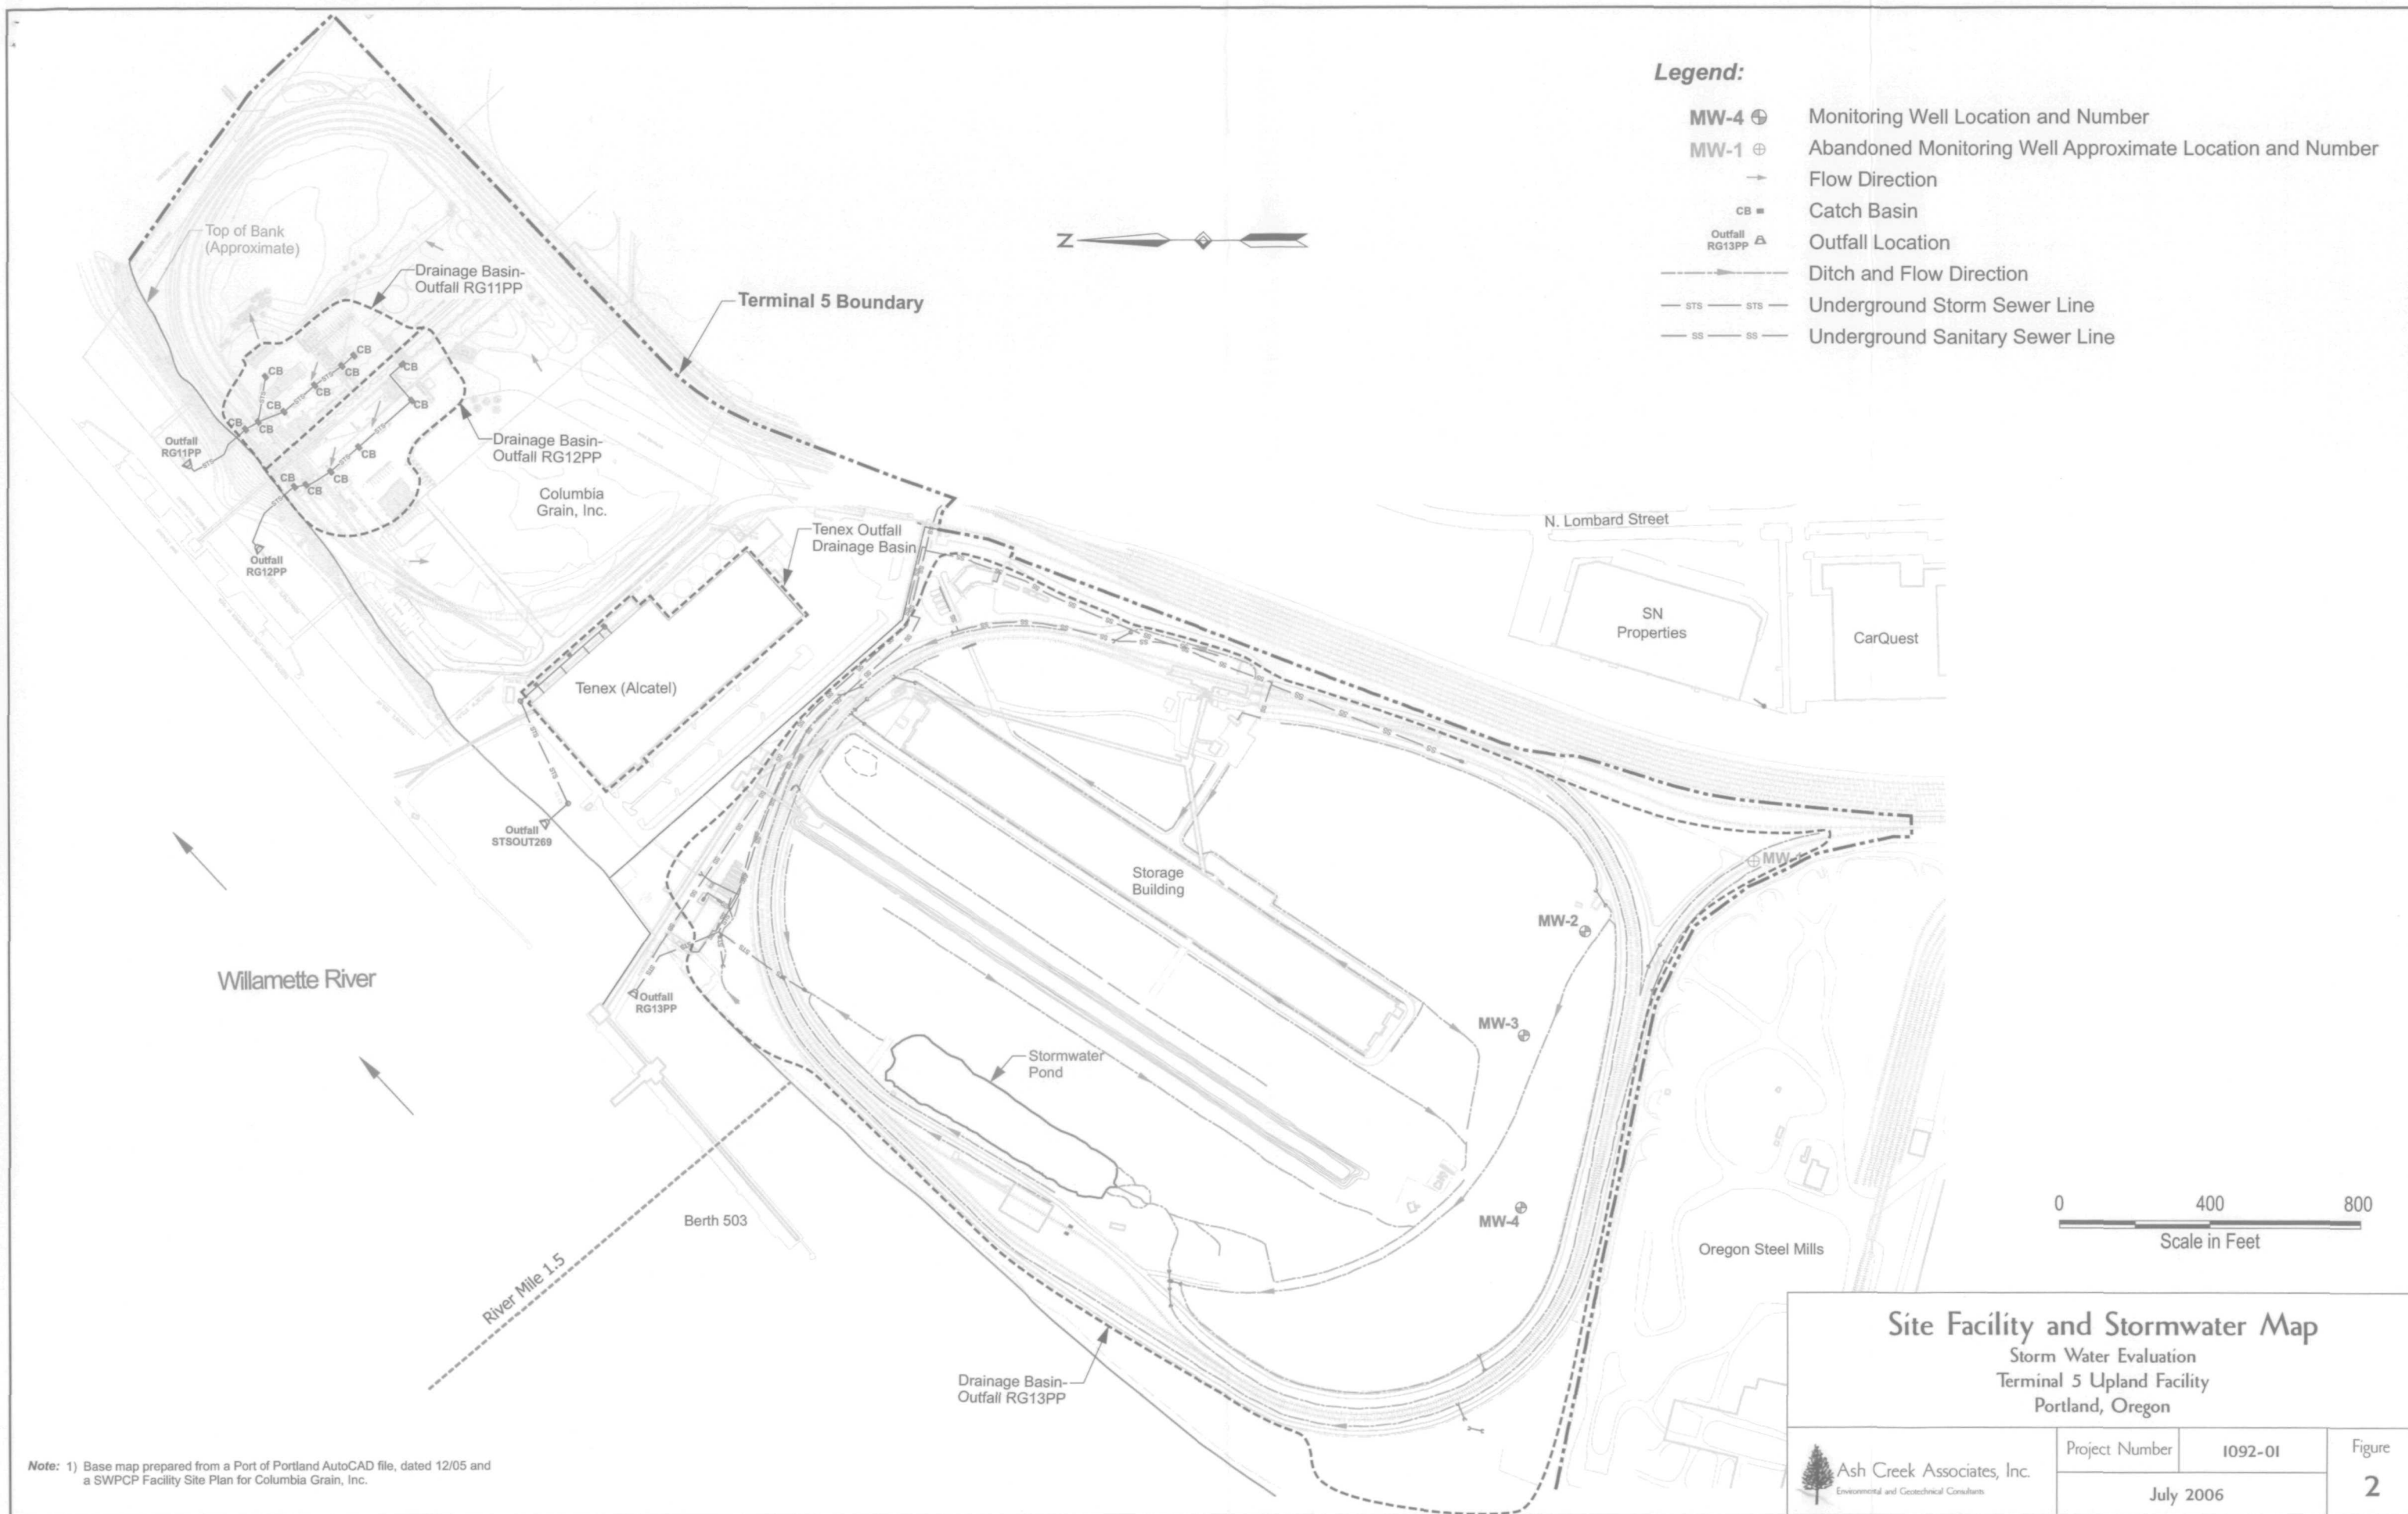
A storm drain system consisting of two drainage basins drains about 80 acres of the PBT facility (Figure 2). The southern basin covers over 70 acres. Of that total area, 10 acres consists of paved roadway and 6 acres is covered with the storage building. The remaining 54 acres are unpaved with the surface primarily gravel (e.g., railroad ballast) or grass. The ground surface is relatively flat with little chance of surface erosion. The storm drain system for the southern

basin consists of surface ditches that lead to a nearly two acre settling pond. The pond discharges to a ditch that leads to a sedimentation manhole, a sampling manhole, and finally to outfall RG13PP on the Willamette River. The northern basin covers about six acres and is entirely paved or covered with small buildings. Storm water drains to a perimeter ditch that discharges to the sampling manhole and then outfall RG13PP.

Over 80 percent of the Tenex parcel is paved or covered with the building. All industrial activities conducted by Tenex are performed indoors. The facility has a storm drain system that collects almost exclusively the building roof drainage and discharges through one outfall, STSOUT269, to the Willamette River (Figure 2).
